DEPARTMENT OF TRANSPORTATION**DIVISION OF ENGINEERING SERVICES**

Hinge-K Pipe Beam Assembly 102A-3: 12/7/09

a111-3 Forging to a110-3 Base Plate

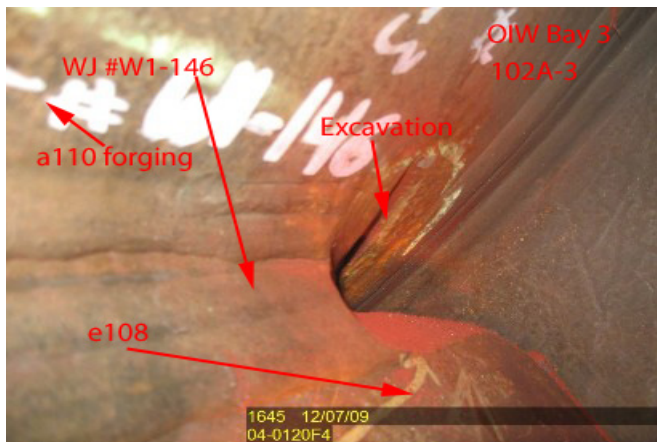
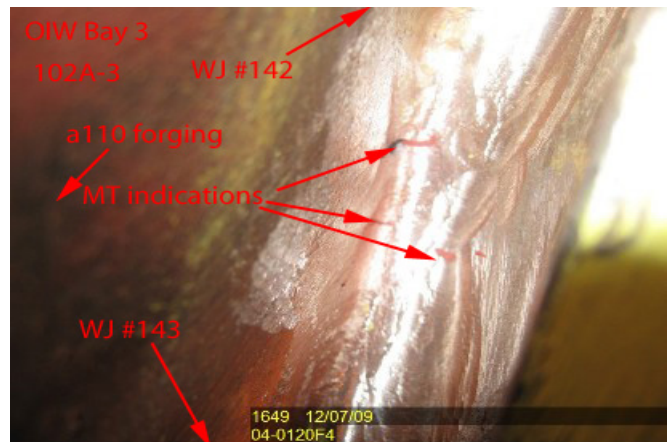
QA Inspector was notified by QC Inspector Jose Salazar that 2 critical weld repairs (CWR's), will be required for

the weld joints designated as # W1-146, W1-142 and W1-143. Mr. Salazar explained that during the magnetic particle inspection on these weld joints, linear indications were present. Mr. Salazar explained that Mr. Tim O'Brian had performed the excavations, to depths of approximately 2-4mm and the indications were still present. QA Inspector verified the excavated areas to be approximately 40mm long and 4mm deep (WJ #146) and 2-10mm long/2mm deep (WJ #142/143). QA Inspector verified that the indications were still present and still needed further excavation, requiring Critical Weld Repairs. QA Inspector noted that these CWR's 009 and 010 were submitted by OIW and are pending approval. See attached pictures below.
